SLIDER CATCH & PUSHBUTTON REPLACEMENT INSTRUCTIONS

830472.002 SLIDER CATCH KIT REPLACEMENT INSTRUCTIONS

830023.001 PUSHBUTTON REPLACEMENT INSTRUCTIONS

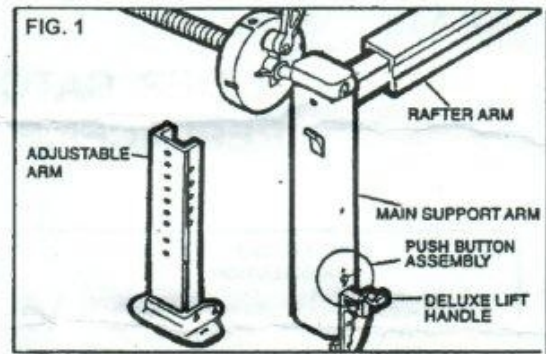
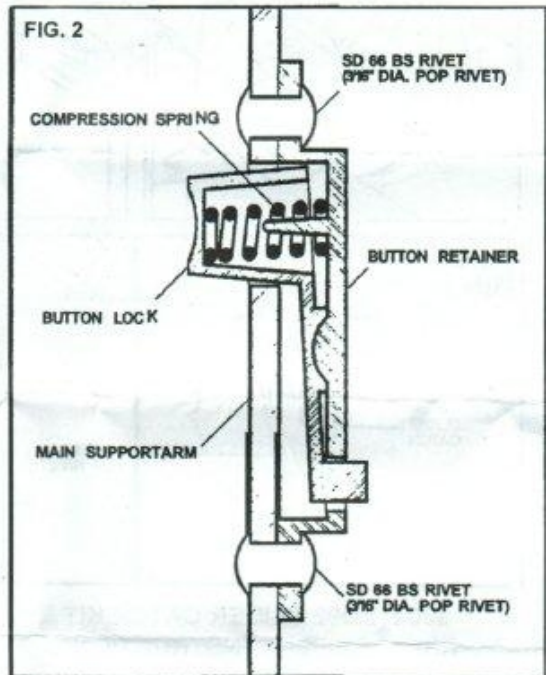
1. Open awning and raise Rafter Arms up to the Slider Catches. Dismount the Support Arm of the defective side from the Bottom Mounting Bracket. Slide out the Adjustable Arm from the Main Support Arm. See FIG. 1.
2. Drill out the two Rivets holding the Deluxe Lift Handle Assembly in place. Use a 3/16" Diameter Drill Bit.
3. Drill out the Rivets using #7 of 3/16" Diameter Drill Bit and remove the defective Push Button Assembly.
4. Assembly new Push Button as shown in Figure 2 and secure in place using SD BS Rivets 3/16" Diameter Pop Rivets.
5. Secure Deluxe Lift Handle to the Main Arm Assembly using two 3/16" x 3/8" Grip Pop Rivets.
6. Slide Adjustable Arm back into Main Support Arm and return Hardware to mounted position.
