## SLIDE-OUTS

This document is for identifying the differences between the Standard (Fig. 1) and Inverted (Fig. 2) gear racks of an In-wall Slide-out system. There are specific repair kits available for the Standard and Inverted gear rack systems.

### Repair Kits Part Numbers

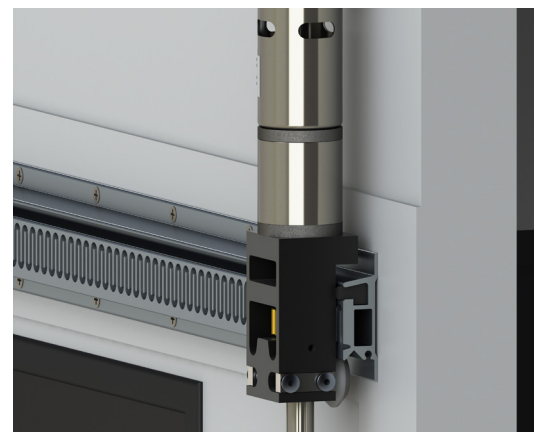
Fig. 1

#### Standard Gear Rack

Upper Rack

Lower Rack

**NOTE:** The assembly images on the right in Figures 1 and 2 are cut-out for clarity. The installed system will not have the same view.

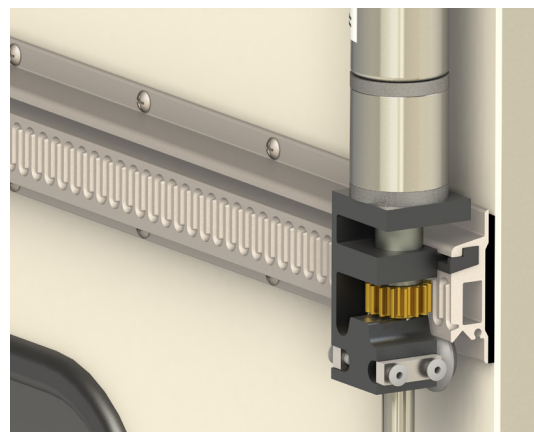
Fig. 2

#### Inverted Gear Rack

Upper Rack

Lower Rack

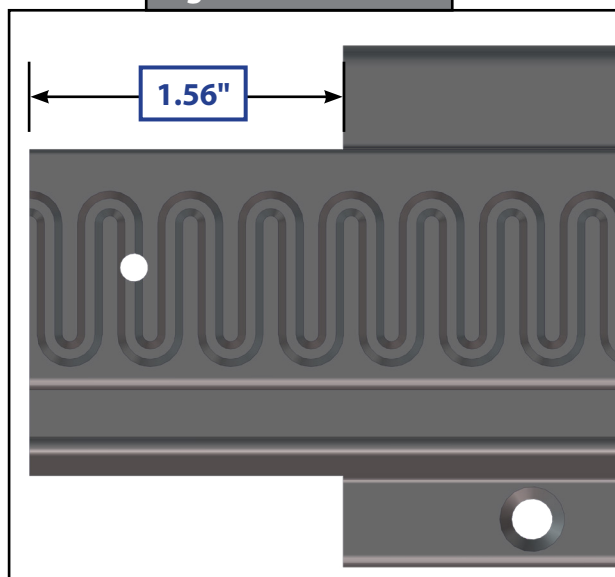
Fig. 3 - 1.56" Notch

#### Standard (w/ 1.56" Notch)

If the system being repaired has a different notch than the 1.56" described in Figure 3, use the images below to identify the notch, then contact Lippert at (432) 547-7378 for ordering assistance.
